Materials in orthodontics

Implant failure

Failure of a ceramic acetabular insert

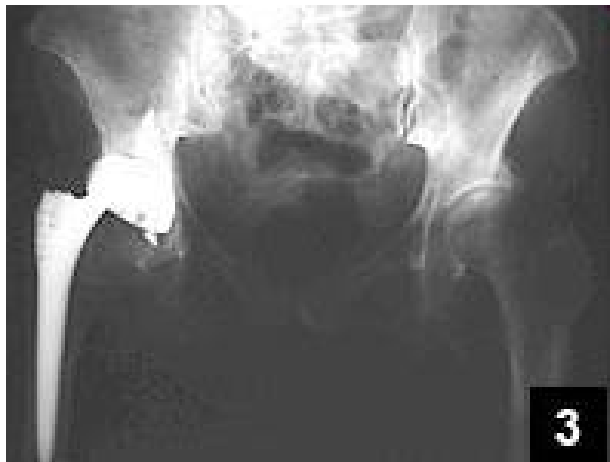
Protrusion of the ceramic head through the PE cup and the acetabular shell in total hip replacement

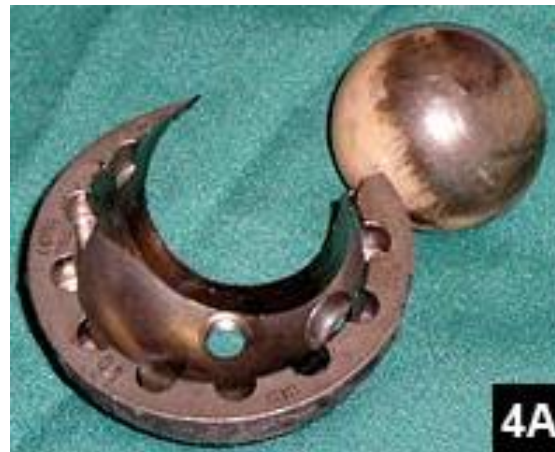
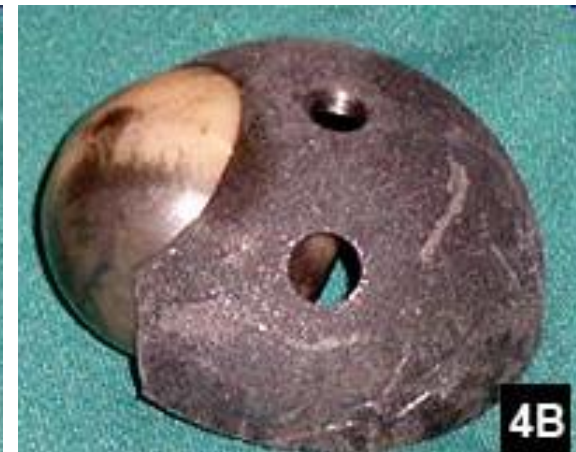
Radiograph before revision surgery
(Prosthesis implanted 3 years ago)

The polyethylene cup had worn off and was broken. The ceramic head was intact. It was duller and blackened on its superior aspect in comparison to its non-contact surface (A). The head had fully penetrated the acetabular shell (B)

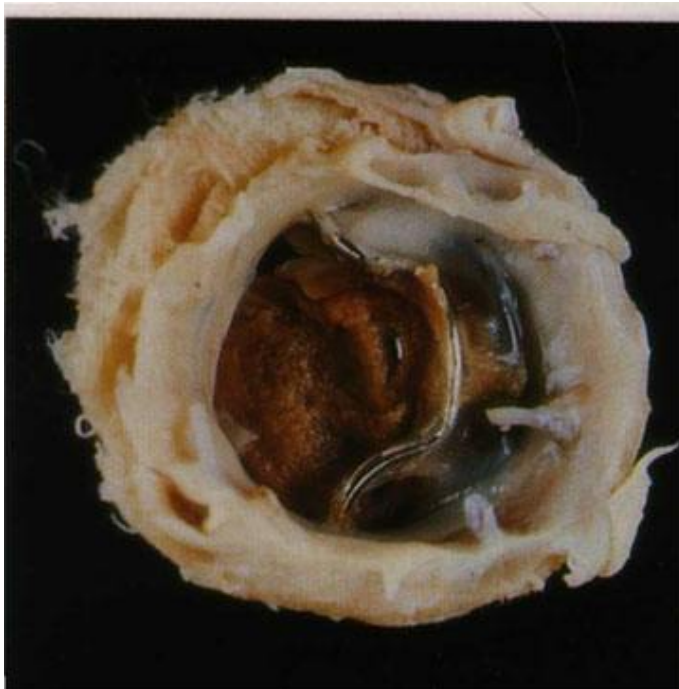
Mechanical heart valve

- Increased risk of blood clotting (anti-coagulants needed)

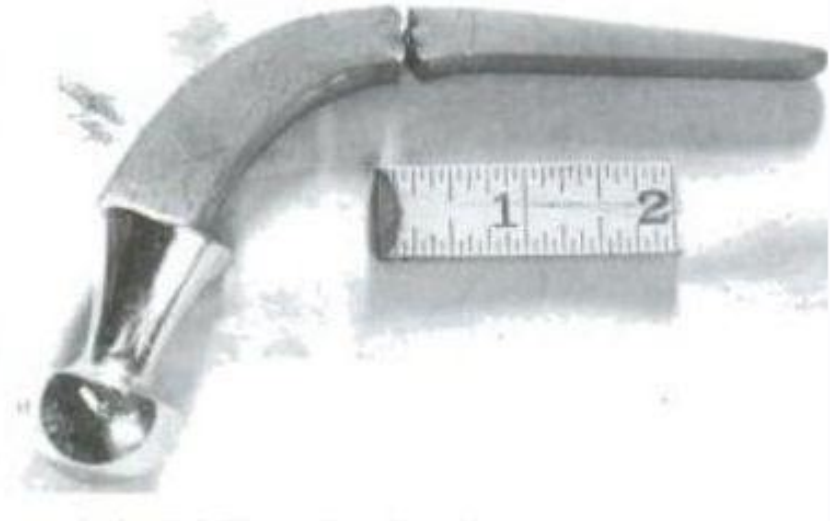
Cast 316 L femoral stem

- Fatigue failure of metal parts

↓
13 months after
implantation

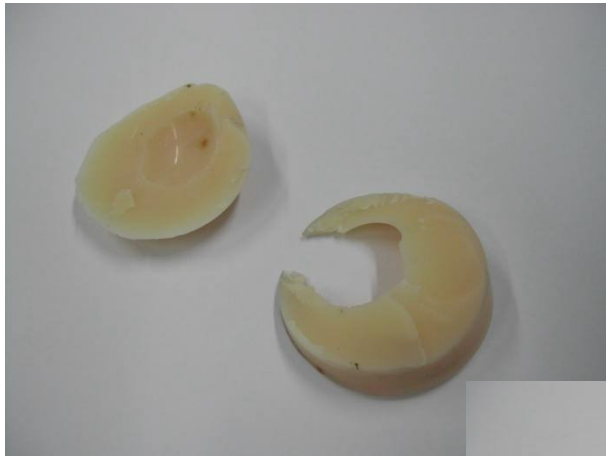
The two biggest fragments are from the upper side of the insert

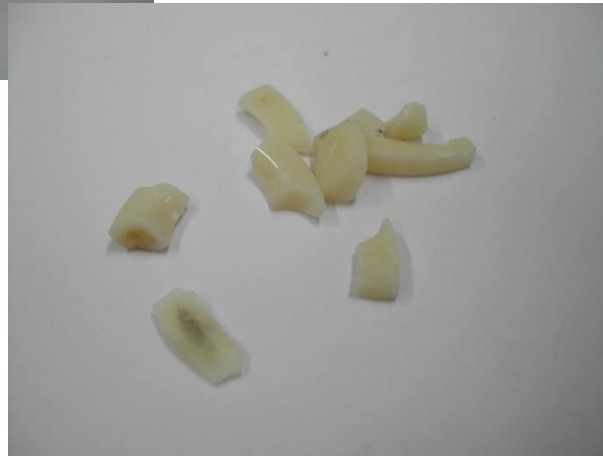
8 fragments are related to the lower part of the insert; one of these fragments should be the failure initiating one

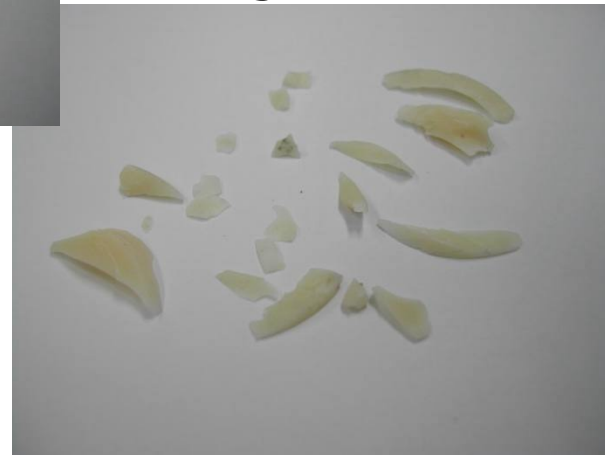
A multitude of small fragments and shivers that are produced during removal of the insert

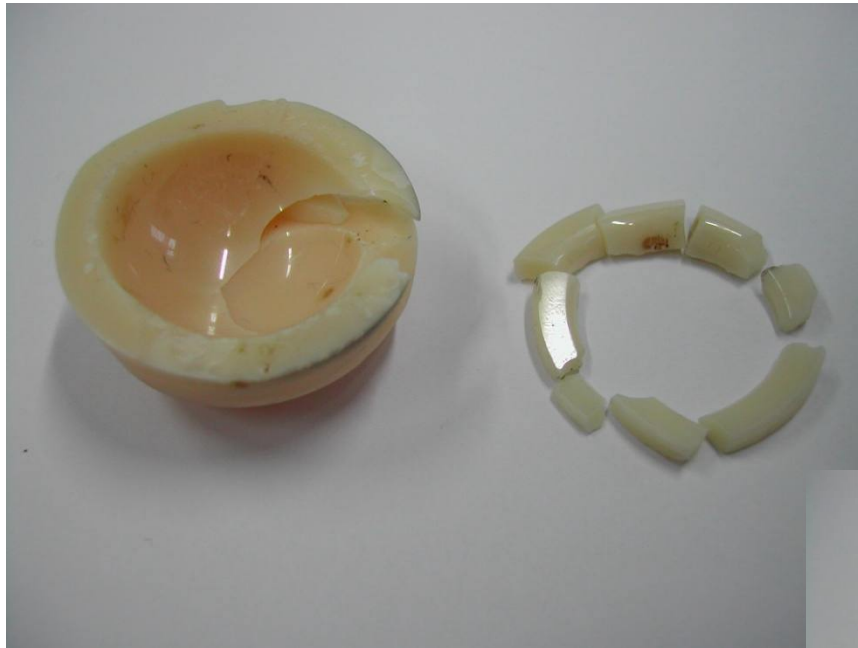
Arrangement of the fragments in the original cup shape

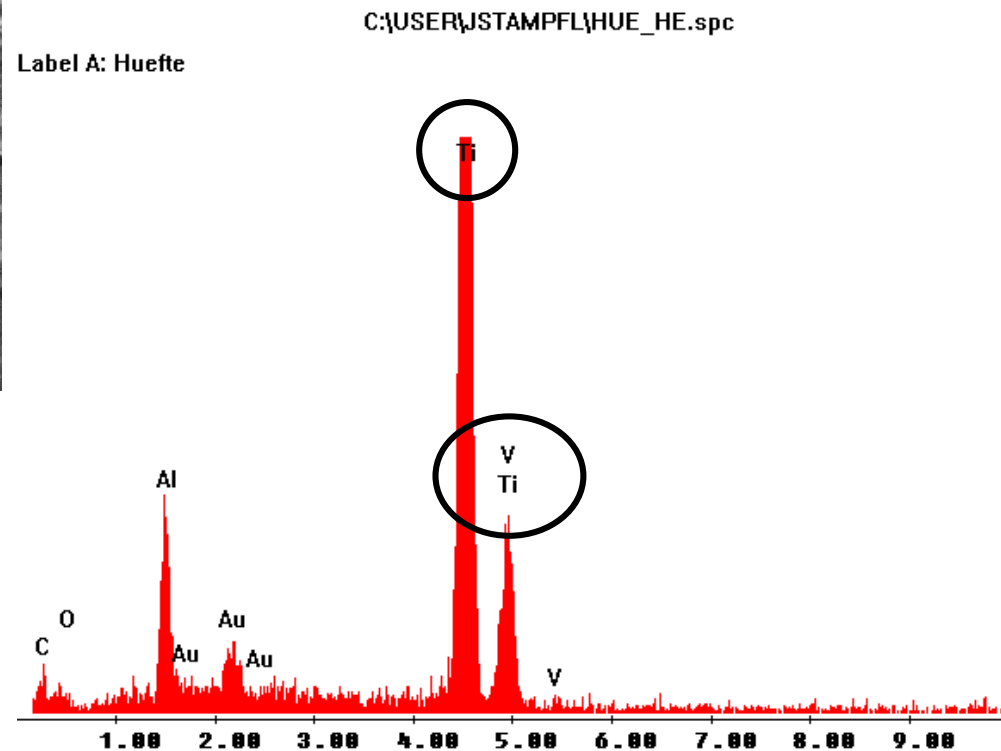
EDX of the Disposal

The disposal is caused by post-fracture clamping of the fragment between insert and Ti overlay.

Al, O ... Elements of the ceramic

C, O ... Elements from the sputtering for electron conductivity
